Manhole Inspection Summary

Manhole # S21E1_010MH

Location Address: **HURON-PIERPONT-ALLEY**

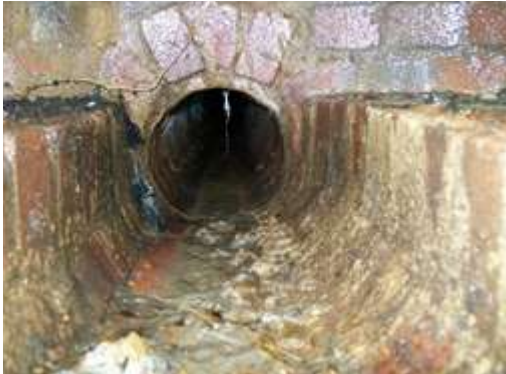
Defect 3

Condition: ☐ Sound ☐ Cracked ☒ **Root Intrusion** ☐ Deteriorated ☐ Leaks ☐ Debris

DEBRIS ON BENCH

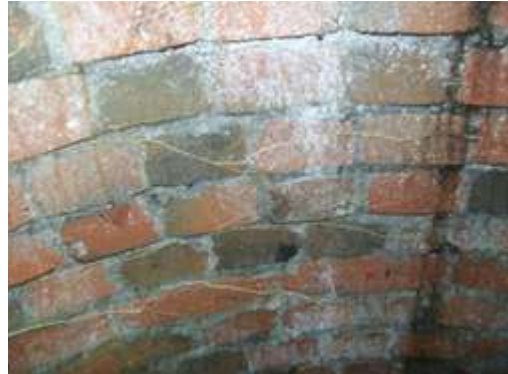
Defect 2

ROOT INTRUSION ON BENCH

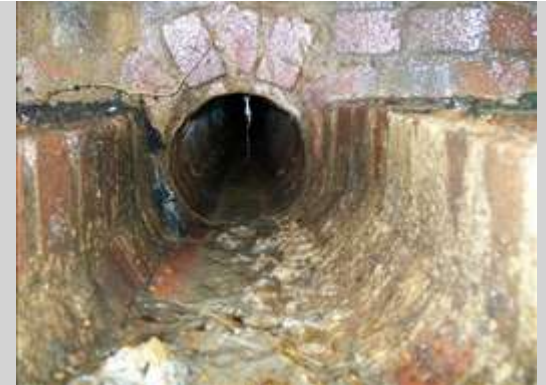
12 O'Clock Outflow

8 in. Circular Gravity Sewer
Pipe Out @ 12 O'Clock

Infiltration: **None** Pipe Seal Cond: **Sound**

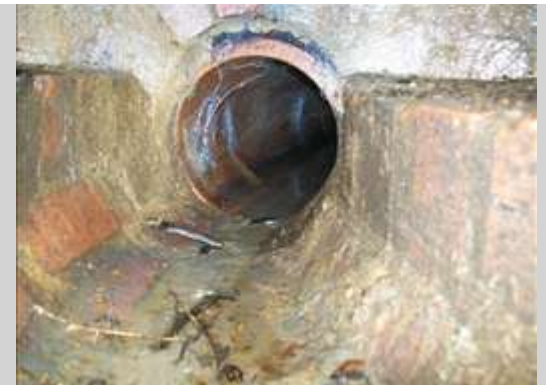
8 O'Clock Inflow

8 in. Circular Gravity Sewer
Pipe In @ 8 O'Clock

Infiltration: **None** Pipe Seal Cond: **Roots**
